# Pipeline Repair

## Oceaneering® Smart Clamp repairs broken and leaking pipeline

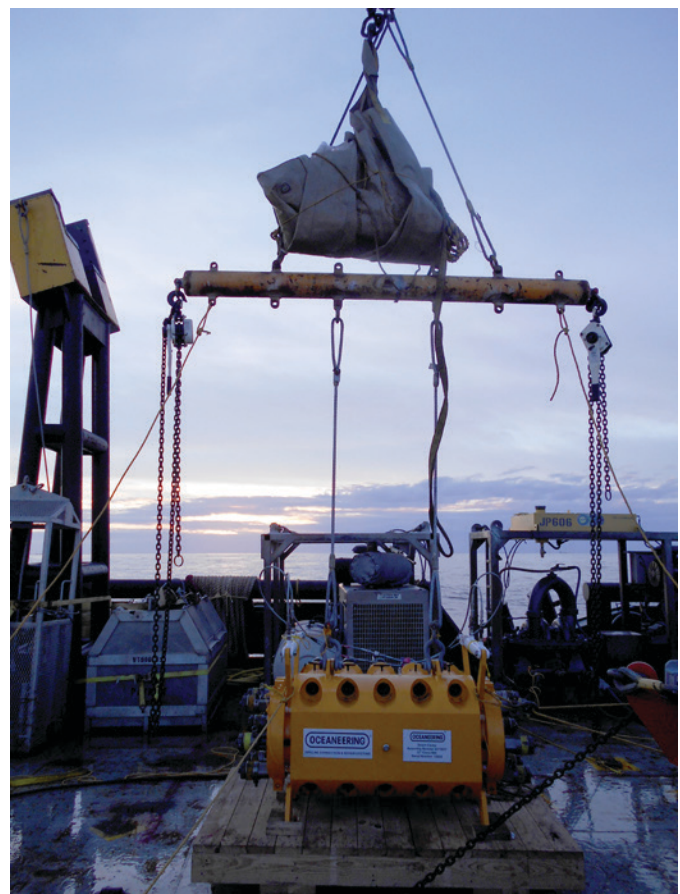
The leak was located at a portion of the pipeline that was buried nearly 7 feet under the sea floor due to heavy shifting currents and underwater mudslides in the area. To assess the damage, Oceaneering divers used an Oceaneering 20Ksi water blaster to remove all the concrete and other coating from the pipeline with zero visibility and working in a 10 foot ditch created during dredging. Dredging was also carried out using an Oceaneering supplier dredging machine.

Rough weather stopped the activities from the dive vessel for two days. Once work resumed, the divers found that underwater currents had separated the pipe completely in two parts because the seafloor was no longer supporting the pipe. The pipeline lay was also off-center of alignment and the field joint was worse than first examined.

Oceaneering Engineers and expert divers determined through calculations and analysis that the crew would be able to pull the two pipe ends within 3 inches of each other and using an Oceaneering® structural Smart Clamp installed over the two loose pipeline ends to reconnect the broken pipeline. The Smart Clamp would then handle all applicable external and pressure loads of the parent pipeline.

The crew and divers then fixed rigging lines with two clamps at each end of the pipeline ends and were able to carefully line up both pipeline ends and hold position while the divers installed the Smart Clamp. Synthoglass protective pipe wrap was used on the exposed areas where coating was removed.
