## Oceaneering repairs leaking pipeline in the offshore Southeast Asia region

Project team successfully remedies fault on 22 inch gas pipeline 80 meters below sea level

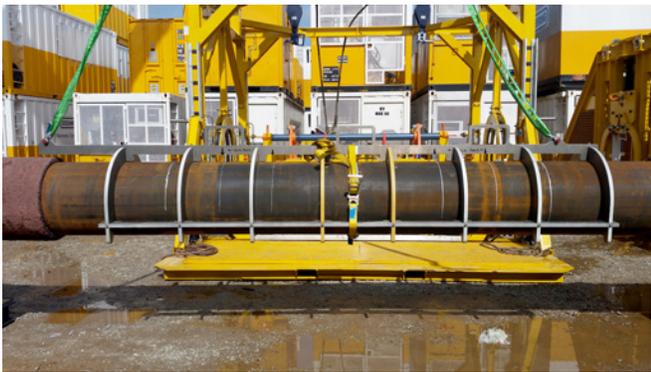
The Oceaneering team also designed and manufactured a deployment frame that could be used to accurately position the clamp over the leak. The deployment frame included a gantry system which allowed the clamp to be suspended within the frame and maneuvered both vertically and horizontally.

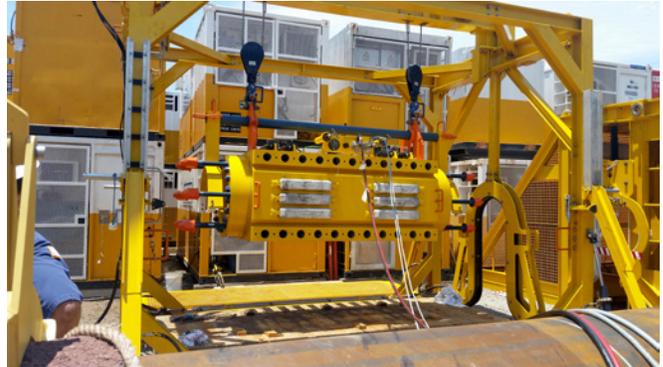
**Stage 1** – Wet storage of equipment (permanent free span rectification frame and 12 inch dredge mud mat assembly). This included confirmation of permanent frame settlement in the seabed which was used as a reference prior and during final installation of the frame post successful clamp installation.

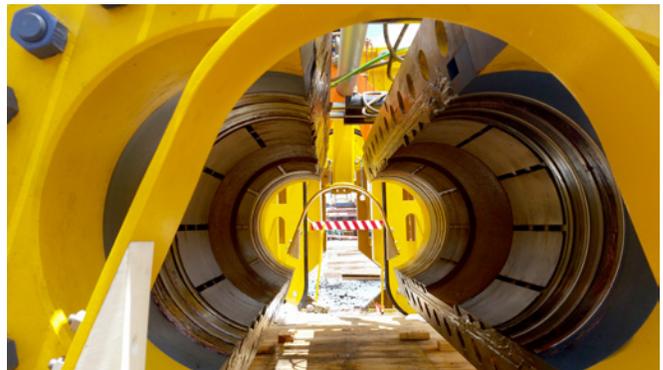
**Stage 2** – We were required to complete the removal of protective concrete coating (19.7 ft / 6 m) and weld seams (9.8 ft / 3 m) from the damaged section of pipeline in order for the clamp to be installed and seal on the pipeline.

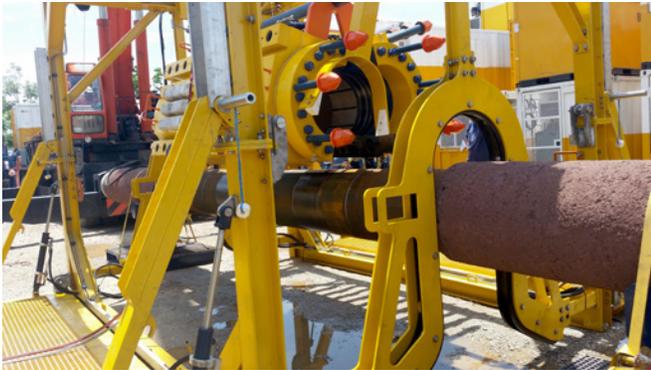
**Stage 3** – Pipeline metrology was also required. A straightness gauge confirmed the pipeline was within API 5L requirements and within tolerance of clamp design. We also successfully

installed the locating clamp which was used for guidance to ensure correct placement of the clamp.

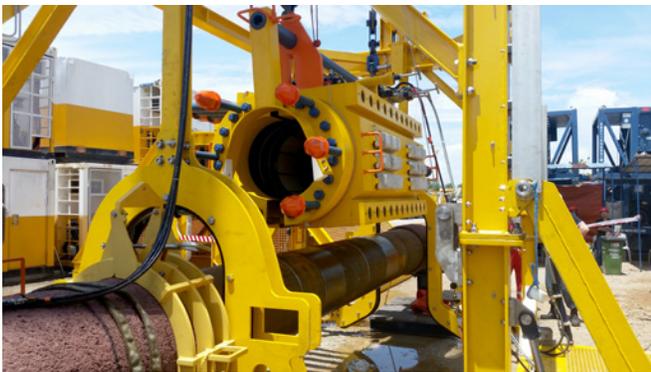
**Stage 4** – Diverless smart clamp installation using bespoke diverless clamp deployment frame involving correct bolt torquing patterns and loads and completion of pressure testing.

**Stage 5** – Installation of permanent free span rectification frame using correct torque figures achieved via Class I-V Torque Tool to ensure additional weight of the pipe was transferred off the pipe onto the frame clamping / jacking mechanism.
