## Oceaneering Completes Installation of Pipeline Repair Clamps

Project restores flow to 48 in pipelines off the coast of Singapore

### Project Overview

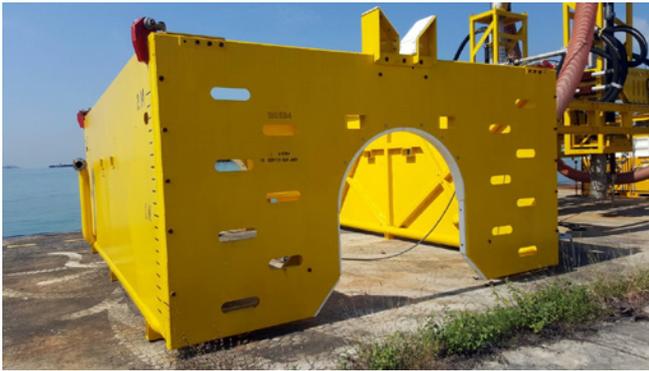
As an industry-leading provider in pipeline repair services and products, we rapidly responded to the customer's mobilization window. Part of this scope included the custom design, fabrication, assembly, and testing of a suitable pipeline coating removal tool (PCRT) within eight weeks. The pipelines size, and additional six inches of concrete weight coat (CWC), ruled out using a rental tool from our standard portfolio. The short lead time required input from engineers and designers based in Australia, India, and Houston, which enabled us to provide continuous coverage and support.

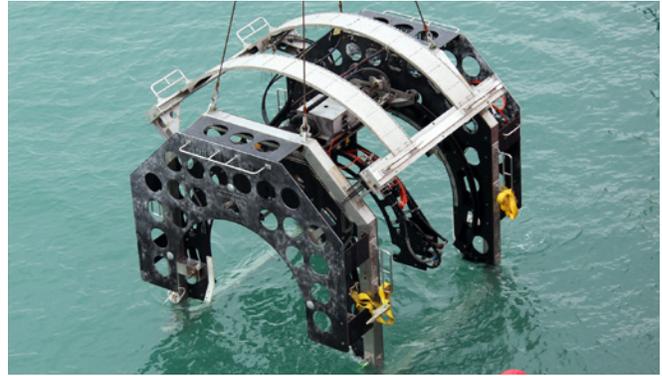
- » Excavation and dredging at the two clamp installation locations, including rock breakup
- » Removal of 7.2 ft (2.2 m) of soil and 6 in of CWC and coal tar enamel/epoxy (CTE) at the two clamp locations
- » Repair clamp positioning
- » Repair clamp installation

The pipelines were half buried in the seafloor. This meant each location had to be dredged roughly 7 ft (2.2 m) deep to provide sufficient access for the PCRT. An estimated volume of 3,500 ft<sup>3</sup> (100 m<sup>3</sup>) of soil was excavated at each location. Divers used Oceaneering's 6 in dredge and high pressure pump to excavate and breakup soil, rock, and grout bags. After each location was successfully dredged to the required depth, the PCRT was deployed and installed by divers.

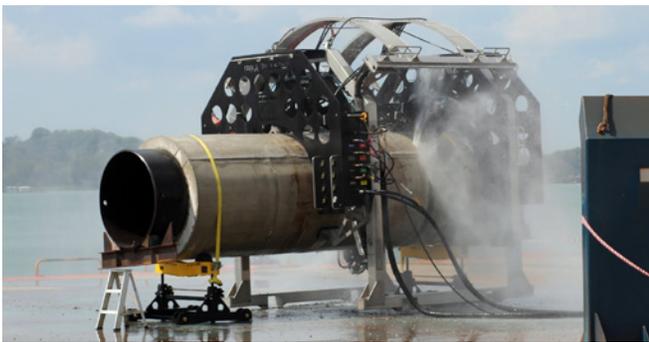
The PCRT was designed to be fully controlled topside using integrated hydraulics. This enabled Oceaneering operators to control linear and circumferential motions, as well as nozzle distance using feedback from a graphic user interface (GUI). The tools were also equipped with several redundant features to maximize cleaning time and mitigate downtime. In order to optimize the monitoring and performance of the tool, the PCRT includes standard with LED cameras, providing an enhanced overview of the cleaning process.

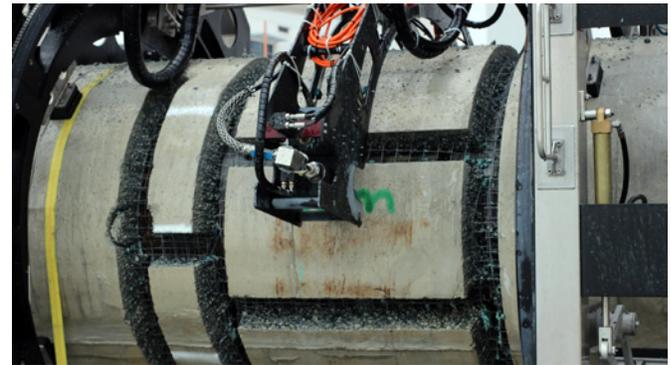
Tooling equipment used to complete the job included an Oceaneering 6 in dredge, 64 in pipeline coating removal tool (PCRT), clamp installation tooling, and high pressure jetting equipment for rock breakup.

Oceaneering's equipment successfully dredged, excavated, removed CWC, polished the pipe and removed all CTE, and assisted in the installation of the two repair clamps at each of the locations. The successful installation of the clamps enabled the customer to extend the life of the pipelines. Although the project saw several variables including quick turnaround, rough currents, and unplanned conditions, Oceaneering was able to support and help complete the project.
