# Rigless Plug and Abandonment

## Project Overview

In 2013, Oceaneering was approached by a major North Sea, Danish Sector operator who requested a review of their legacy inventory of 28 suspended Exploration and Appraisal (E&A) wells. The majority of the wells were mudline suspension types with spud dates ranging from 1966 through to 1998 and water depths ranging from 110 to 237 ft (33.5 to 72.2 m).

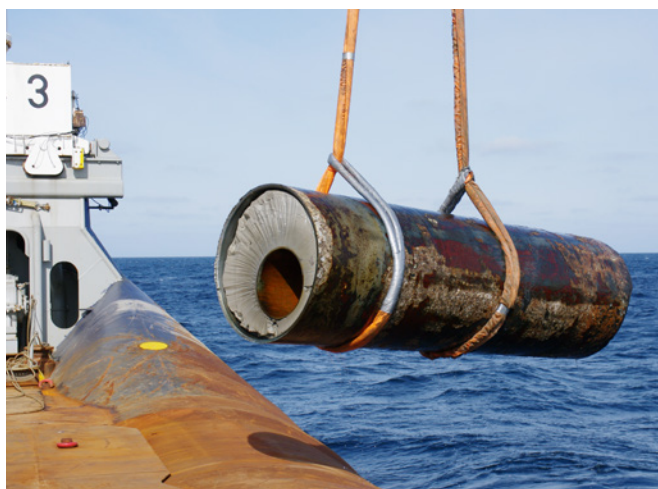
**Debris clearance and structure recovery:** All debris clearance and structure recoveries were assessed to be well within the scope of standard ROV, rigging, and construction crane operations.

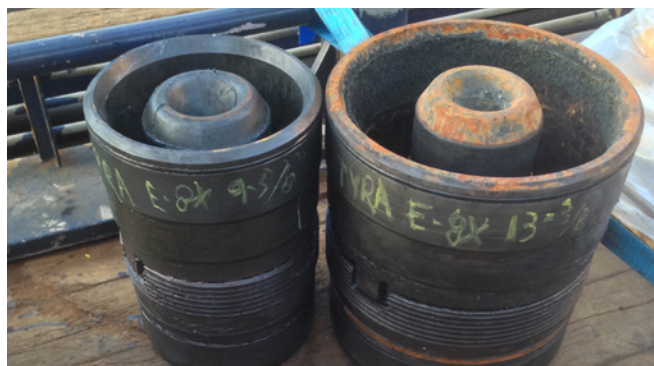
**TA cap recovery:** Given the requirement to vent, pressure test, and recover numerous TA caps (multiple OEMs, stab-in, threaded, vented, and back pressure valve [BPV] types), vessel-deployed drill pipe tooling solutions were employed to provide the highest level of flexibility.

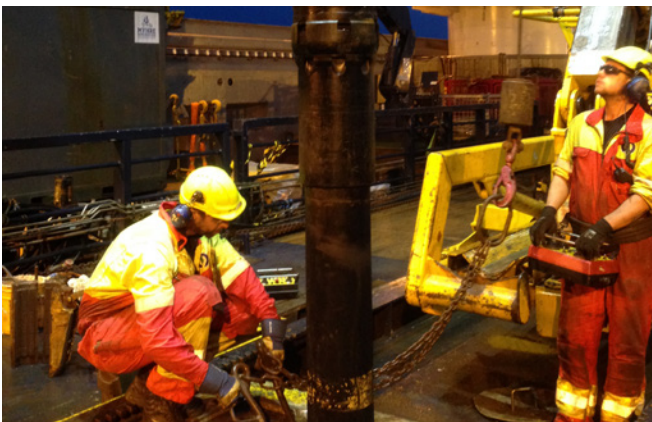
**Cementing:** Two techniques were available to place the cement plugs as per the applicable regulations; punch and squeeze or pump and pull. The client's preference, based on assurance of the optimum quality, was to employ the pump and pull technique.

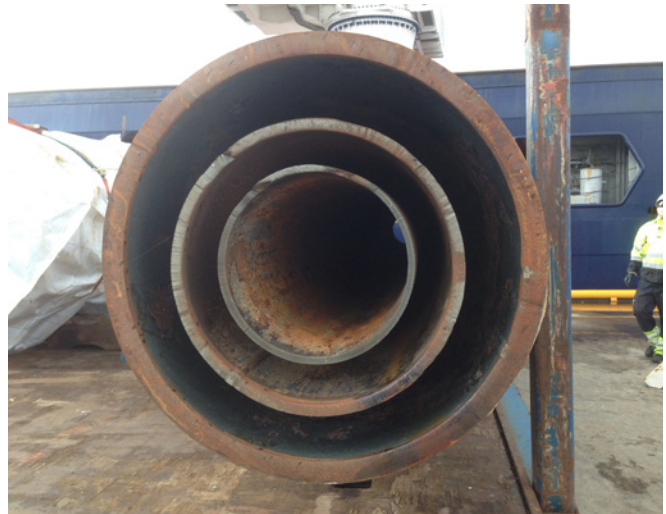
**Well Severance:** Oceaneering-supplied internal abrasive water jet and diamond wire cutting solutions were identified as the only appropriate options for final well severance. Explosive severance is still sometimes used in the industry; however, given the unknown consequences of peak pressure shock waves on the integrity of the remaining well barriers, let alone the damage caused to the marine flora and fauna, the use of explosives use, even as a backup, was not considered viable.
