## Oceaneering repairs leaking pipeline in the offshore Southeast Asia region

Project team successfully remedies fault on 22 inch gas pipeline 80 meters below sea level

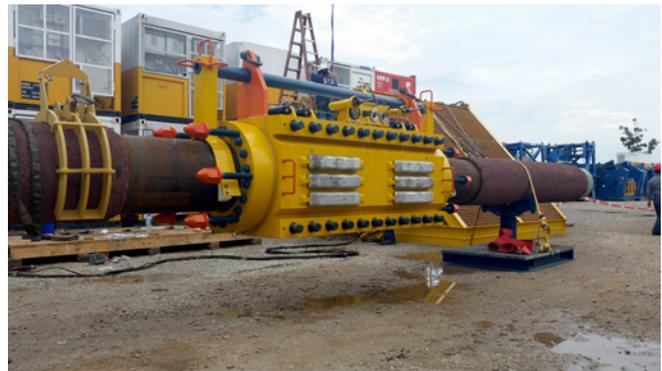
The clamp was successfully deployed, installed, and sealed the leaking pipeline. The design life of the clamp is in excess of 25 years and ensures the customer can execute safe, successful operations for decades to come. Our experience and products enabled the customer to maintain flow of gas through the pipeline while we executed the repair.
