Grayloc® Connectors Survive High-Pressure Hydrogen Fire with Sealing Integrity Intact

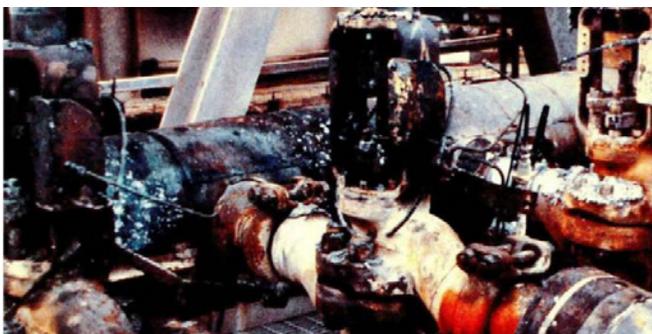
The photograph shows the level just above the leaking valve packing gland, within 15 ft (4.5 m) of the main reactor vessel. The intense heat destroyed three control valves; their operator housings were melted and their control functions were completely lost. These valves, installed with Grayloc® connectors, were within 2 ft (.6 m) of the melted operators.

The Grayloc® clamps provided the only structural support for the valves, and close inspection revealed that the connectors neither leaked nor loosened.
